VILLAGE OF HASTINGS-ON-HUDSON COMMUNITY FOREST MANGEMENT PLAN

SAVATREE CONSULTING GROUP

December 10, 2021

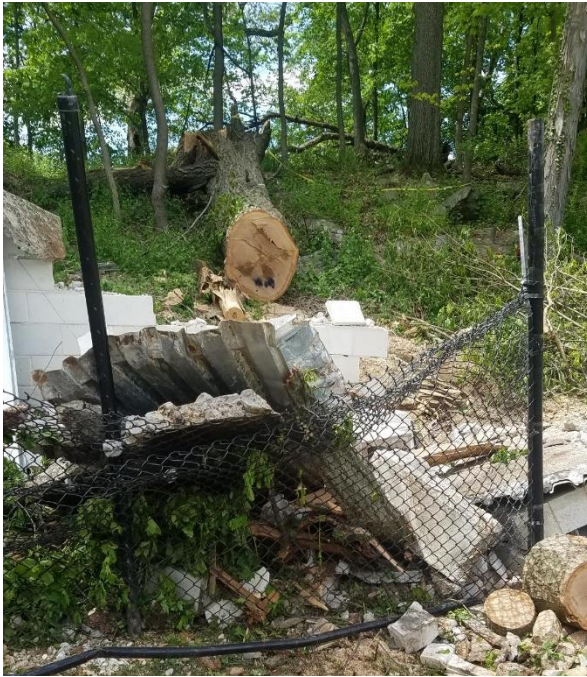
Photo taken by the Village of the tree that failed onto the dugout at Uniontown Park. Although the tree was healthy, its base had significant decay.

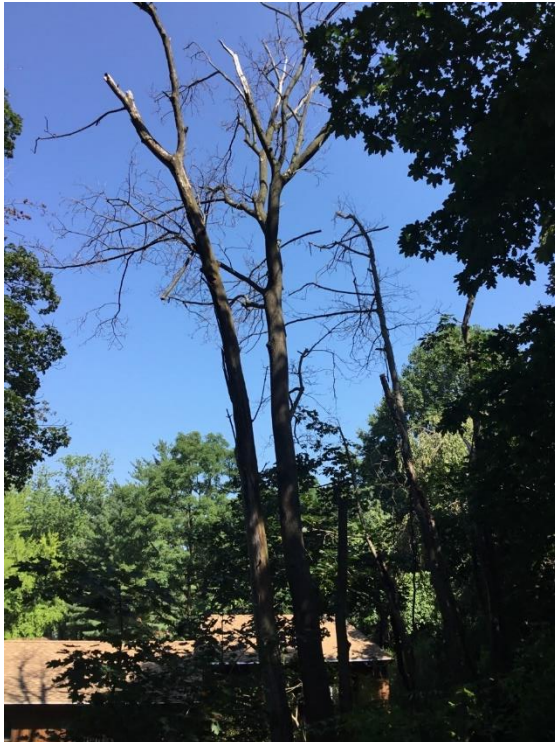
Photo 1 – Photo taken during the inventory showing Trees 1721 and 1722. These are standing dead trees located at north border of Zinsser Park in proximity to a residence on Wagner Place. The tree on the right (1721) leans toward the house and is rated as High risk. The trees on the left (1722) leans parallel to the wooded edge and is Moderate risk. Both trees are High priority removals.

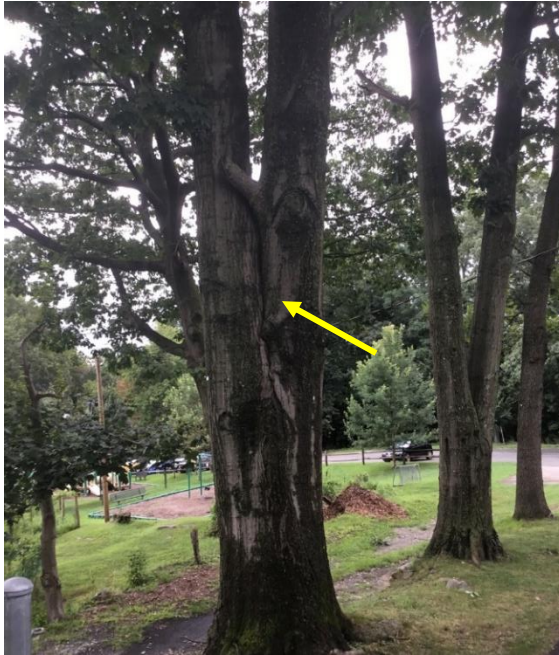
Photo 2 – Photo taken during the inventory showing Tree 1664 in Zinsser Park. The weak point of this tree is the codominant union with included bark (yellow arrow). Installation of a supplemental support cable and canopy reduction pruning will help to reduce the risk associated with the tree from Moderate to Low. This is a High priority recommendation.

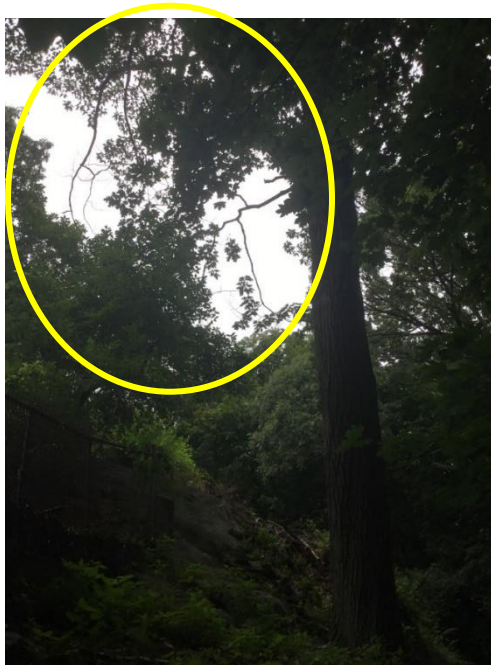
Photo 3 – Photo taken during the inventory showing Tree 1423 on the western edge of Pulver's Woods. There is large deadwood in the canopy over the fence line of a property along High Street. Pruning of this deadwood is a Medium priority recommendation.
