Hastings-on-Hudson, NY
Street Tree Inventory Report

Prepared for the Village of Hastings-on-Hudson
by Brett Schneiderman

October 1, 2013

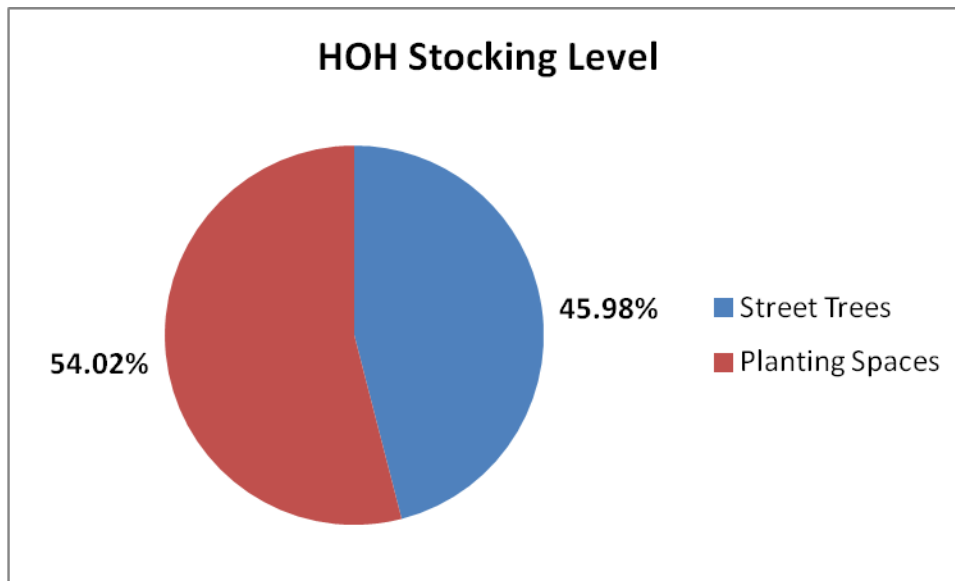
The street tree inventory accounted for 1036 trees and 1217 planting spaces located in the village's right-of-way. The proportion of trees to potential street trees translates into a 45.98% street tree stocking level (see graph below). A 60% stocking level is the national average and most municipalities have stocking levels between 50 and 75%.

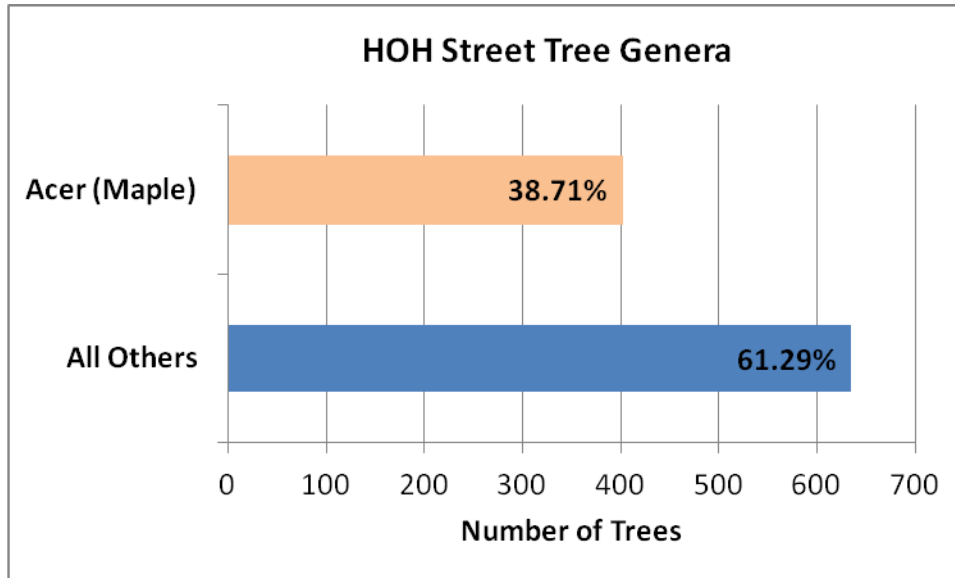
The partial inventory accounted for 1036 trees located in the village's right-of-way. A significant percentage of the trees inventoried (38.71%) were Maples (*Acer* genus) (see graph below).

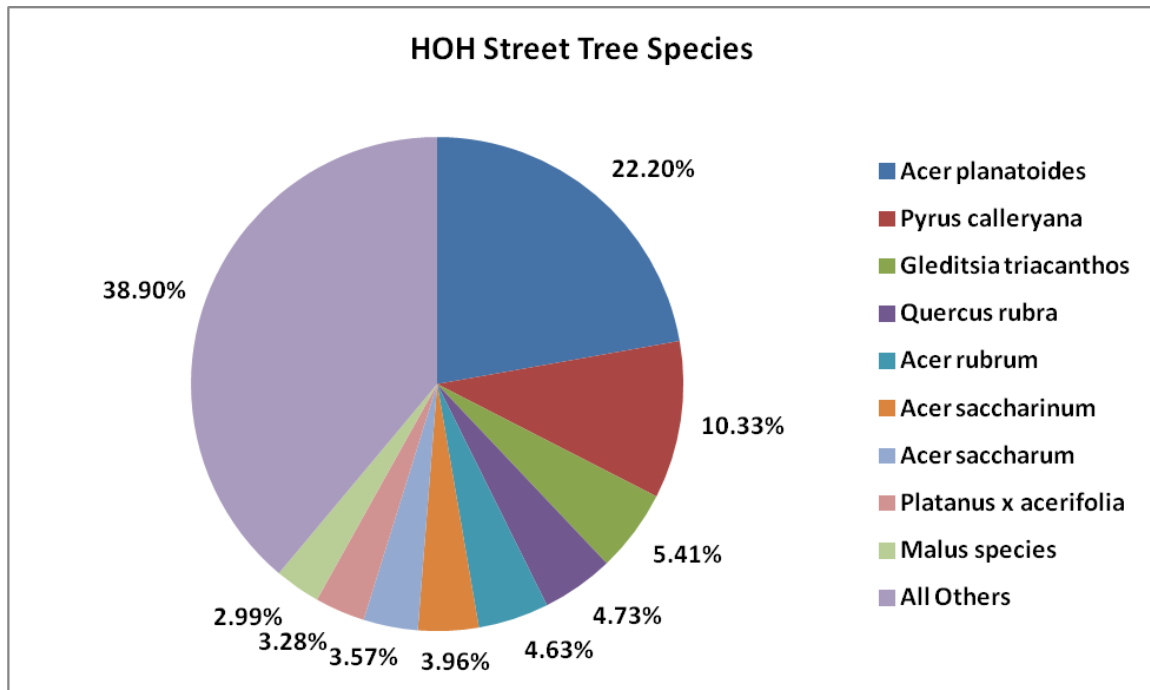
Regarding the population of inventoried street trees, Norway Maple (*Acer platanoides*) accounted for 22.20%, Callery Pear (*Pyrus calleryana*) 10.33%, Honeylocust (*Gleditsia triacanthos*) 5.41%, Northern Red Oak (*Quercus rubra*) 5.41%, Red Maple (*Acer rubrum*) 4.63%, and Silver Maple (*Acer saccharinum*) 3.96% of all inventoried trees (see graph below).

As a general rule, no one tree species should constitute more than 10% of the street tree population and no one tree genus should exceed 20% of the street tree population. For species, the percentages of Norway Maple (22.20%) and Callery Pear (10.33%) exceed the 10% rule and indicate these species are overrepresented in the population. For genus, the percentage of trees in the *Acer* genus (38.71%) exceeds the 20% rule and indicates that Maples are significantly overrepresented in the population.

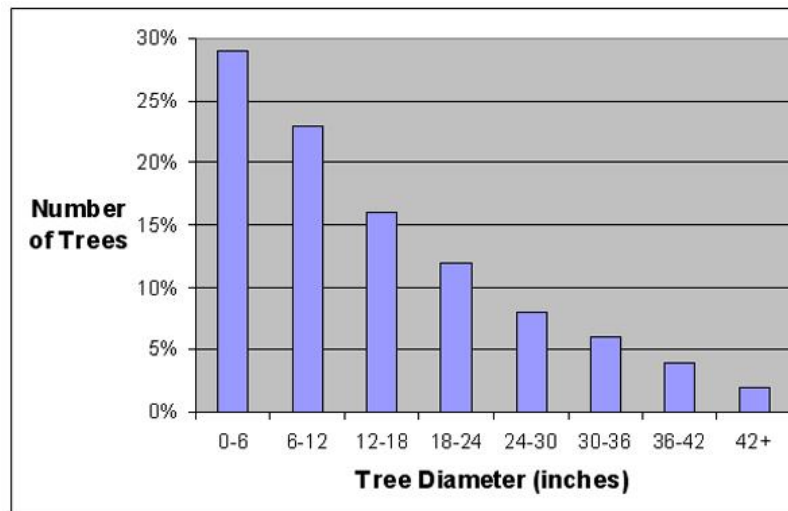
If a community is planting trees regularly, the following J-shaped trend line should be observed for its trees, tapering off at the larger (older) sizes (see graph below).

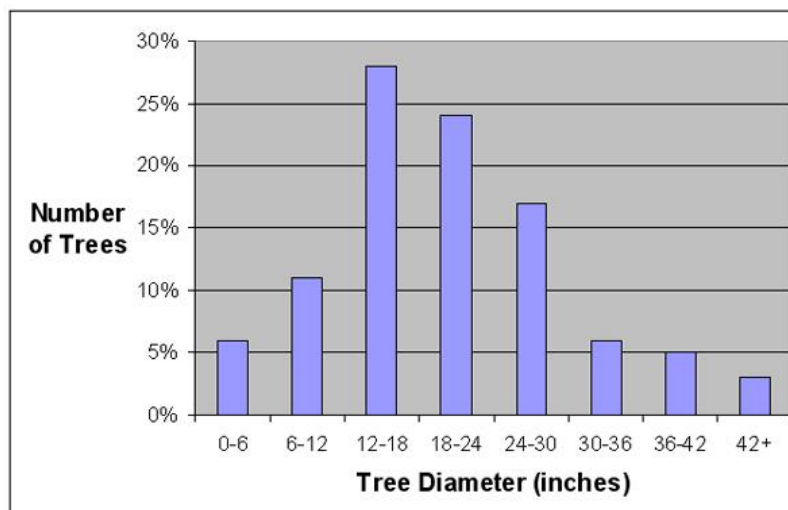
If, however, a community is not planting trees regularly, the following trend line may be observed for its trees, where a disproportionate share of its trees are in the larger (older) sizes (see graph below).

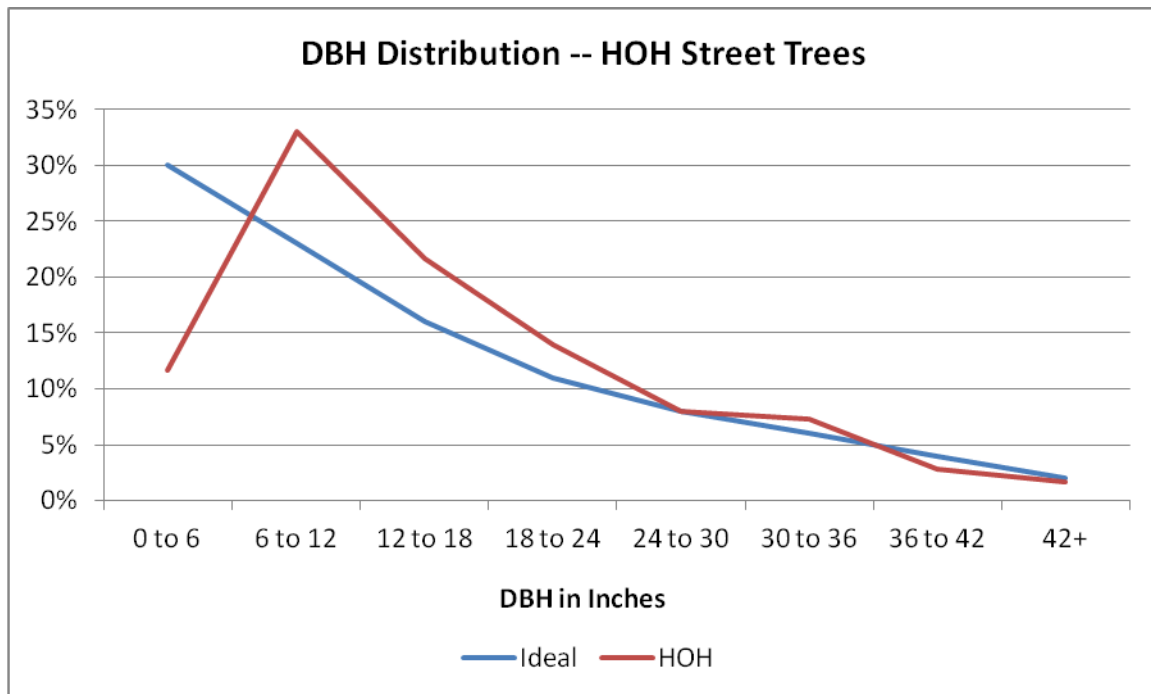
The graph below plots the DBH distribution for Hastings-on-Hudson inventoried street trees against an ideal, J-shaped distribution.

This graph suggests an insufficient number of young trees are currently being planted in the city's right-of-way to compensate for the future loss of older trees. This is also reflected in the distribution of Norway Maple (*Acer platanoides*), the most prevalent street tree in the village.

The DBH distributions derived from the street tree inventory indicate that the overall street tree population is aging and that additional new trees need to be planted to compensate for tree mortality in order to maintain street tree stocking levels at least at its current percentage. Inventory results also indicate that the street tree population is insufficiently diverse with a disproportionately large number of Norway Maples, and Maple trees more generally. As a general rule, no one street tree species should comprise more than 10% of the overall street tree population and no one street tree genus should comprise more than 20% of the overall street tree population. That way, if a street tree species or genus becomes susceptible to an insect or disease, a majority of a community's trees will likely not be affected. Both Norway Maple (*Acer platanoides*) and Callery Pear (*Pyrus calleryana*) were found to violate the 10% rule for species and Maple (*Acer*) was found to violate the 20% rule for genera. Therefore, new street tree plantings should primarily include genera other than Maples and species other than Norway Maple and Callery Pear.

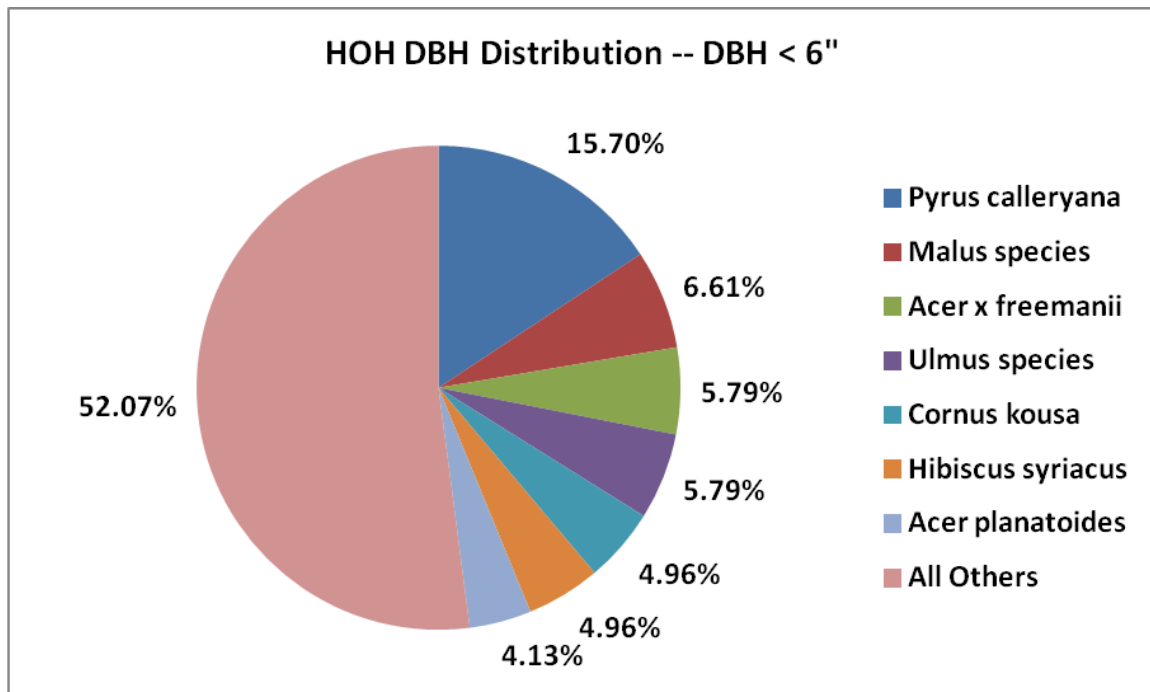
The two graph below depict the DBH distribution of inventoried trees by species for trees with a DBH less than 6 inches.

Callery Pear (*Pyrus calleryana*) and Crabapple (*Malus species*) are the most prevalent species in this DBH class.

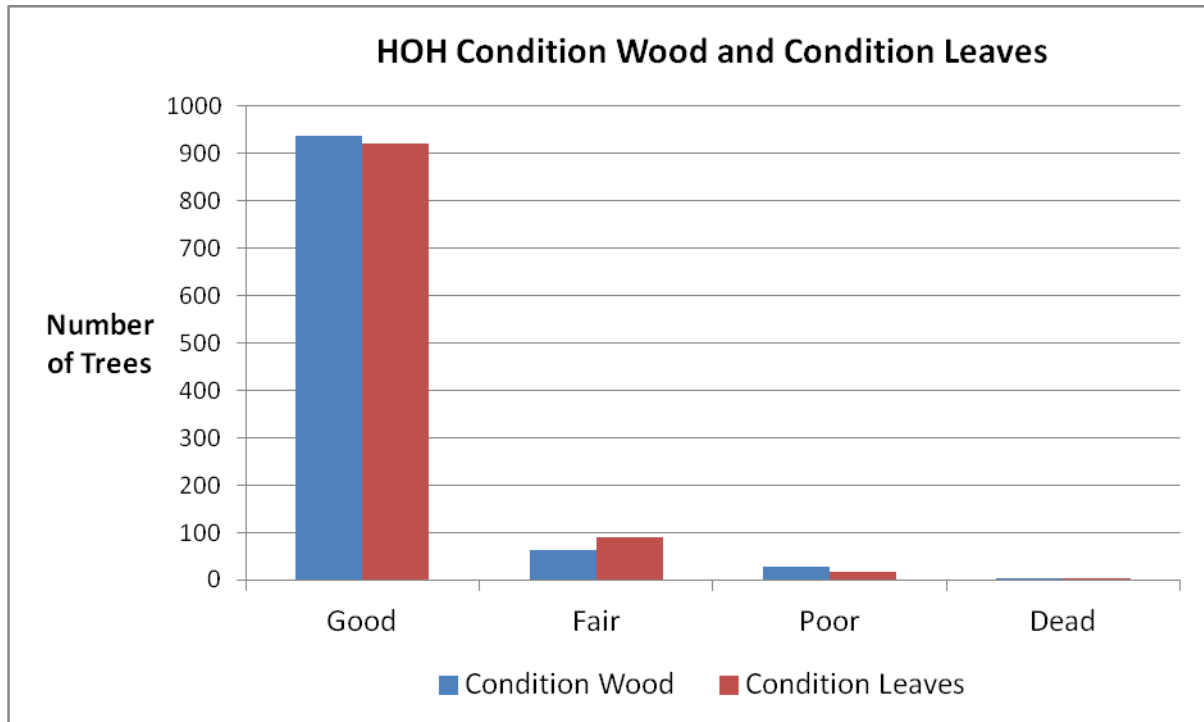
Most street trees inventoried in Hastings-on-Hudson were found to be in good condition (see graph below).
